University of Natural Resources and Life Sciences, Vienna

Master Thesis

ASSESSMENTS ON THE IMPACT OF STONE BUNDS ON WATER EROSION IN THE GUMARA MAKSEGNIT WATERSHED, NORTHERN ETHIOPIA

June 2015

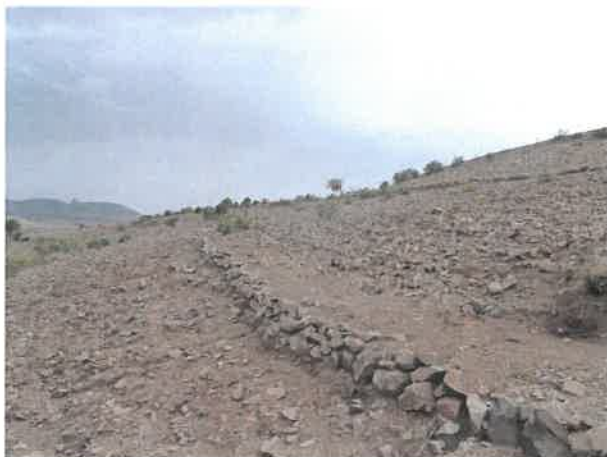
Stone bunds can be defined as embankments of stones built along the contour lines across sloping land in order to reduce the velocity of overland flow and soil erosion (Nyssen et al., 2009). The usage of stone bunds has short - term and long - term effects. In the Gumara – Maksegnit watershed, stone bunds are a widely spread soil conservation method and its installation along the contour lines is shown in Figure 2 and 3. Optimally they are slightly graded in order to induce lateral runoff along the stone bunds.

Figure 3: Representative stone bund in the Gumara – Maksegnit watershed

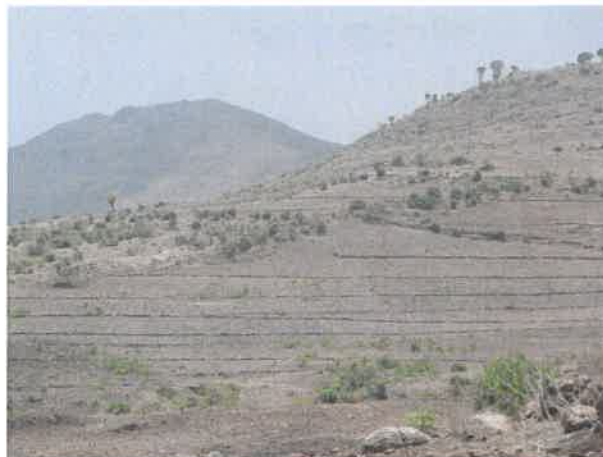
Figure 2: Sequence of stone bunds in the Gumara – Maksegnit watershed

The stone bunds in the Gumara – Maksegnit watershed are made out of rocks which are equally distributed over the cultivated lands. At first local farmers construct a stone bund – skeleton with stones of a size between 10 and 20 cm. Afterwards the holes and gaps become filled up with smaller stones. The height of a typical stone bund in that region ranges from 0.15 to 0.4 m. Nyssen et al. (2009) show that short - term effects of stone bunds are the reduction of the slope length and the creation of small retention basins for runoff and sediment. Short – term effects reduce the volume and erosivity of the overland flow and lead to a decrease of soil loss. The reduction of soil erosion rates due to the reduction of slope length by stone bund building can be compensated by an increase of soil erosion due to rock fragment removal (Nyssen et al., 2007).

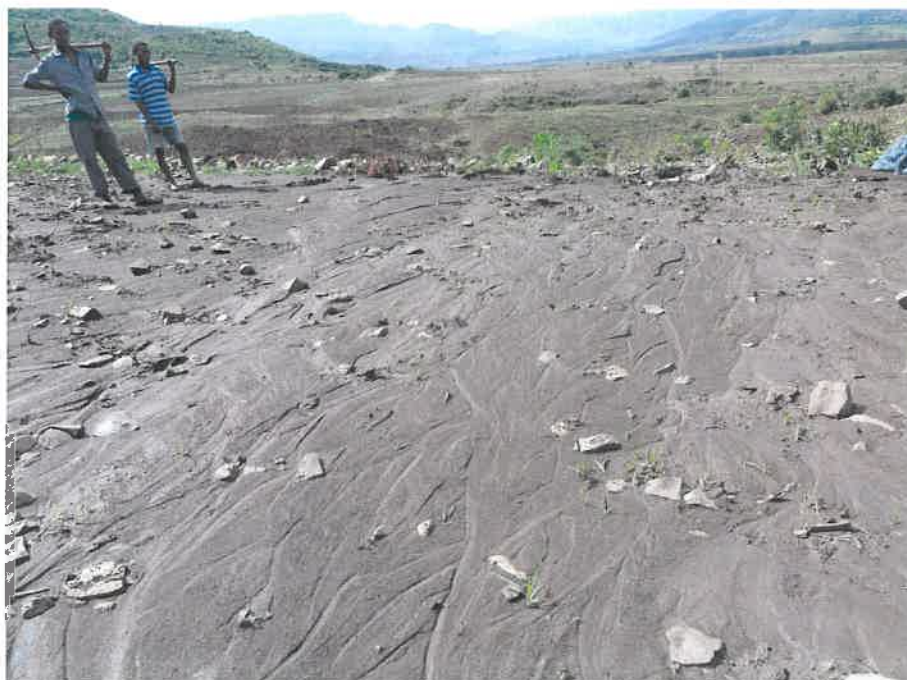
Desta et al. (2005) found out that stone bunds can reduce annual soil loss caused by sheet and rill erosion by 68%. The trapping efficiency decreases when the depression behind the stone bund gets filled, therefore regular maintenance and an increase of height are necessary in order to ensure the positive effect of a stone bund.

Figure 5: Accumulation of sediments in front of the stone bund

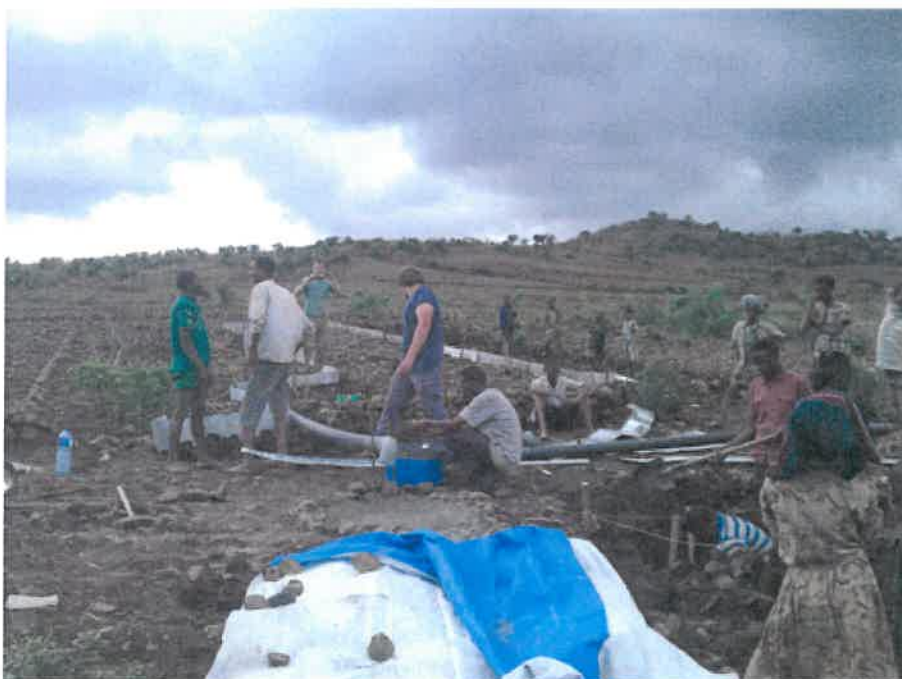
The construction of the treated plot, which is shown at figure 9, started in the middle of June. It was very important to construct the plot fast, since the first big precipitation events of the annual rainy season occurred already in the beginning of June. Once the treated plot was constructed, the decision was made to construct the untreated plot in order to have reference data to compare with. On 4th of July the first samples from the treated plot could be taken and on 13th of July the first samples could be taken from both plots.

Figure 9: Construction works for the plots

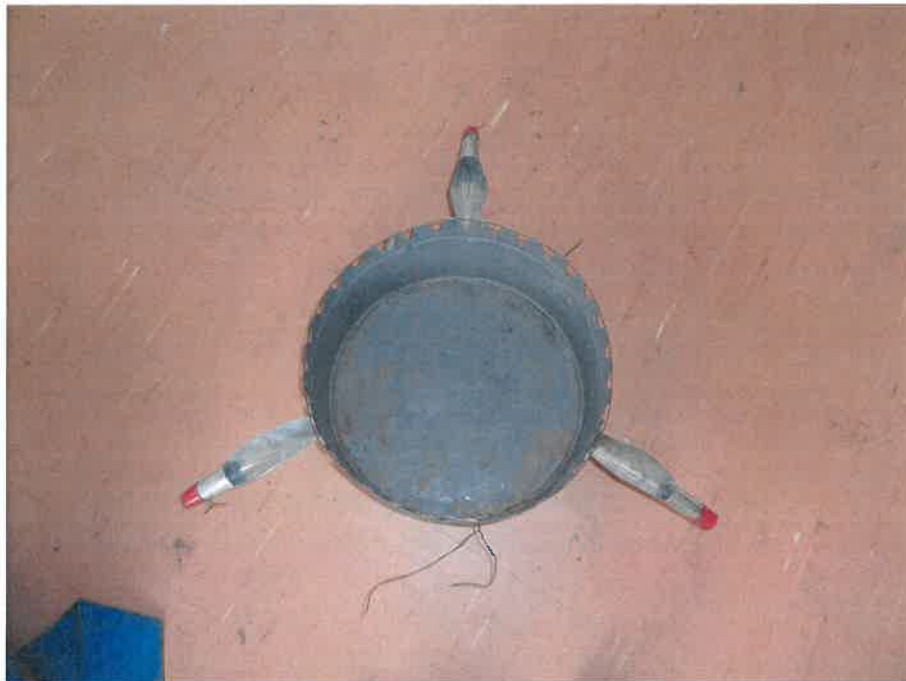
Because of very high expected surface runoff, caused by high precipitation events, there was the idea of dividing the runoff into equal parts and transferring only a part of it to the sampling ponds. For that reason, the decision was made to use sample dividers. The possibility of building well working sample dividers was strongly limited. As material for building the dividers, there were only old iron barrels from a local market with a height of 90 cm and a diameter of 50 cm available. With an iron saw, one barrel was manually cut into two equal sized parts with a height of 45 cm. Then, at the open side of the barrel half, there were 30 (at the untreated plot) or 31 (at the treated plot) equal sized V - shaped apertures cut in similar distances along the circumference. As it is shown in figure 10, at every 10th opening there was a connection part installed, in order to connect a tube of 25 mm diameter with one aperture of the sample-divider. In total there are three connections for a tube per sample-divider in the same distance. With that system the transfer of 10.0% or respectively 9.7% of the total surface runoff from the plots to the ponds was possible.

Figure 10: Sample-divider

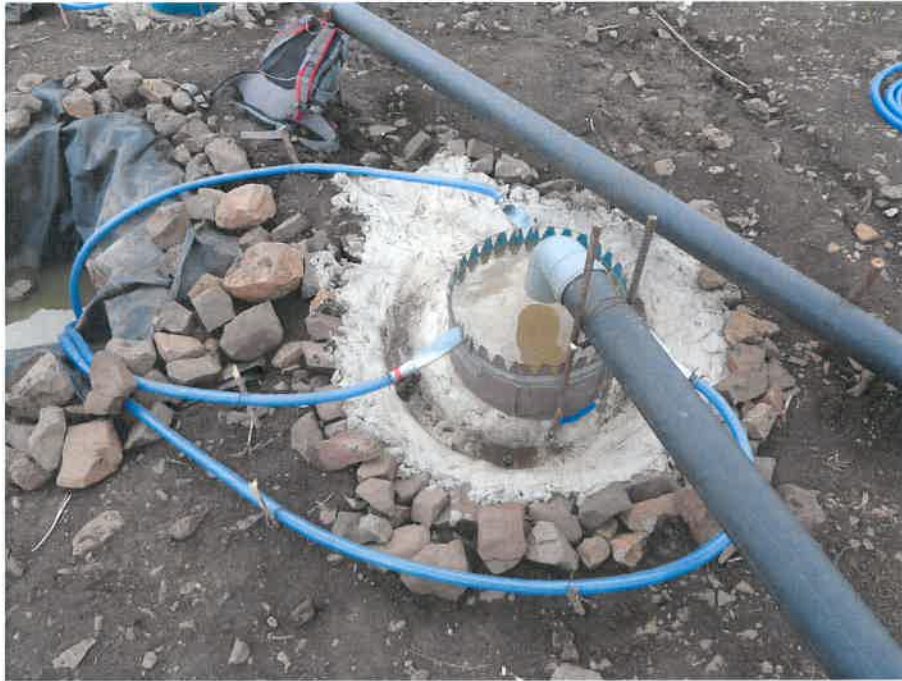
Figure 11 shows the sample-divider installed at a plot. Three tubes of 25mm diameters transfer 10.0% or respectively 9.7% of the surface runoff from the erosion plots to the ponds. The sample divider is set up on a concrete foundation which is circuted by a concrete pan. The other 90% of the surface runoff, which are not transferred to the pond, flow through the apertures of the sample-divider into the pan and finally they flow via an outlet into a draining ditch. It took the first precipitation events to fill the divider with sediments. After that, all the sediments which came with new surface runoff went through the apertures of the divider equally.

Figure 11: Sample-divider installed at the plot

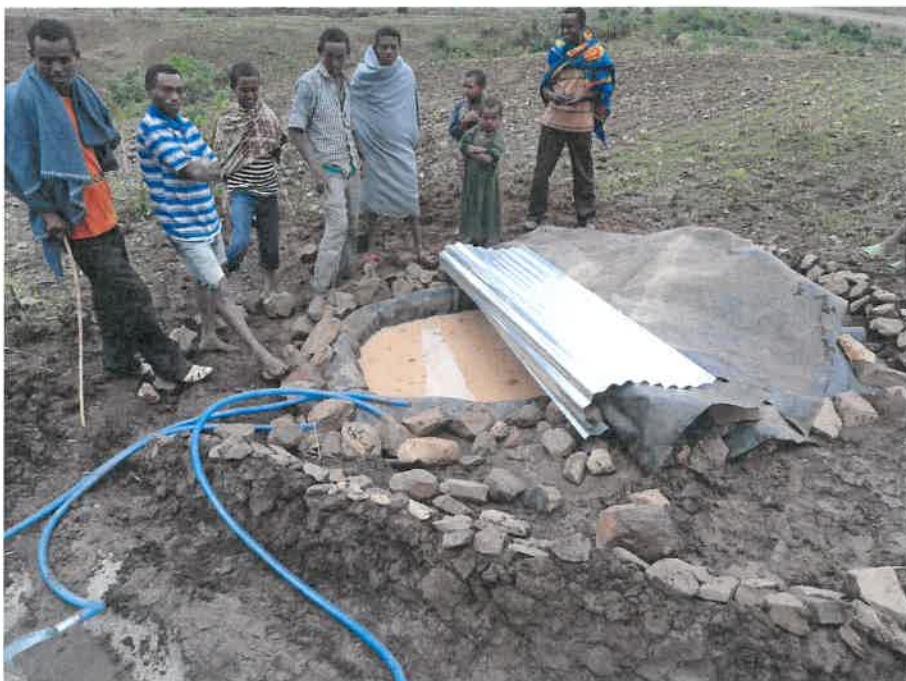
Figure 13: Full pond after heavy precipitation events

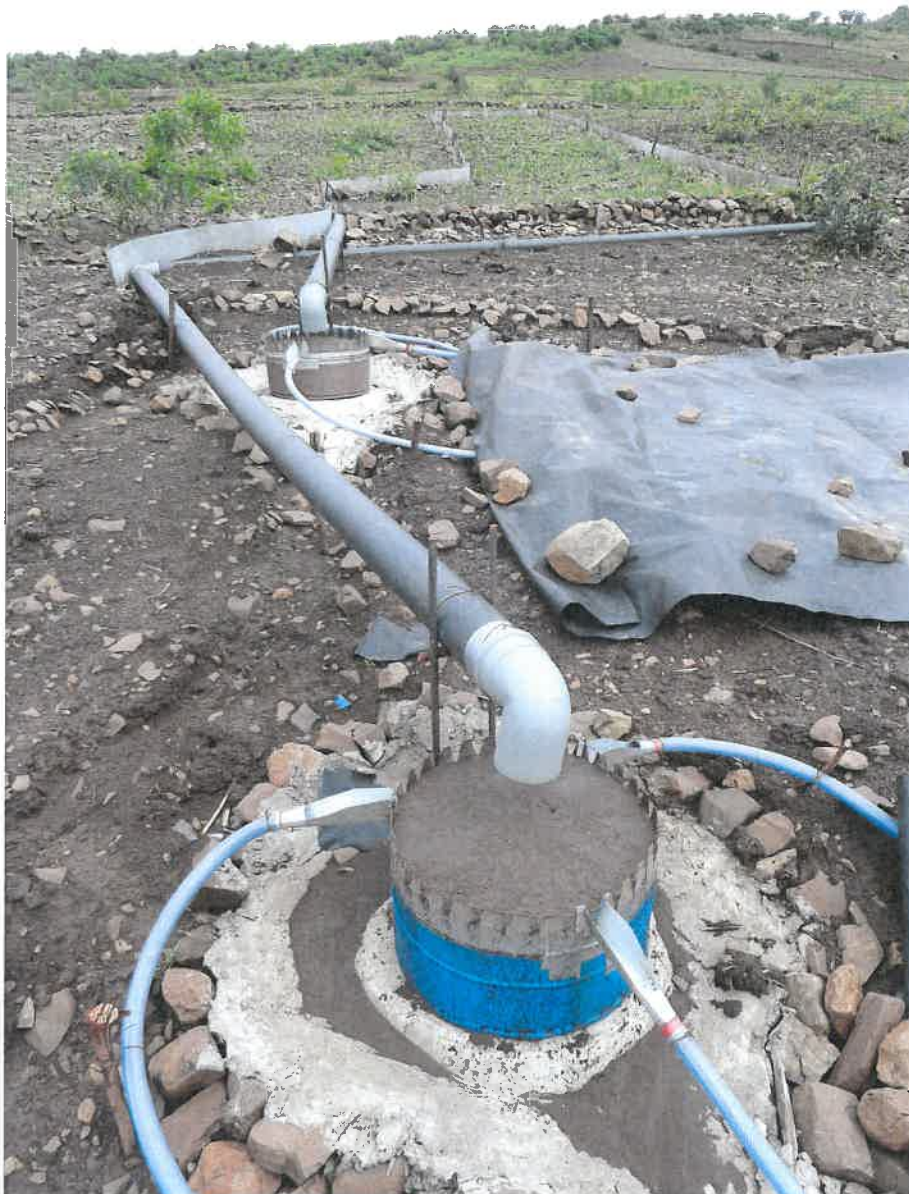
Figure 15: Treated plot, ready for operation

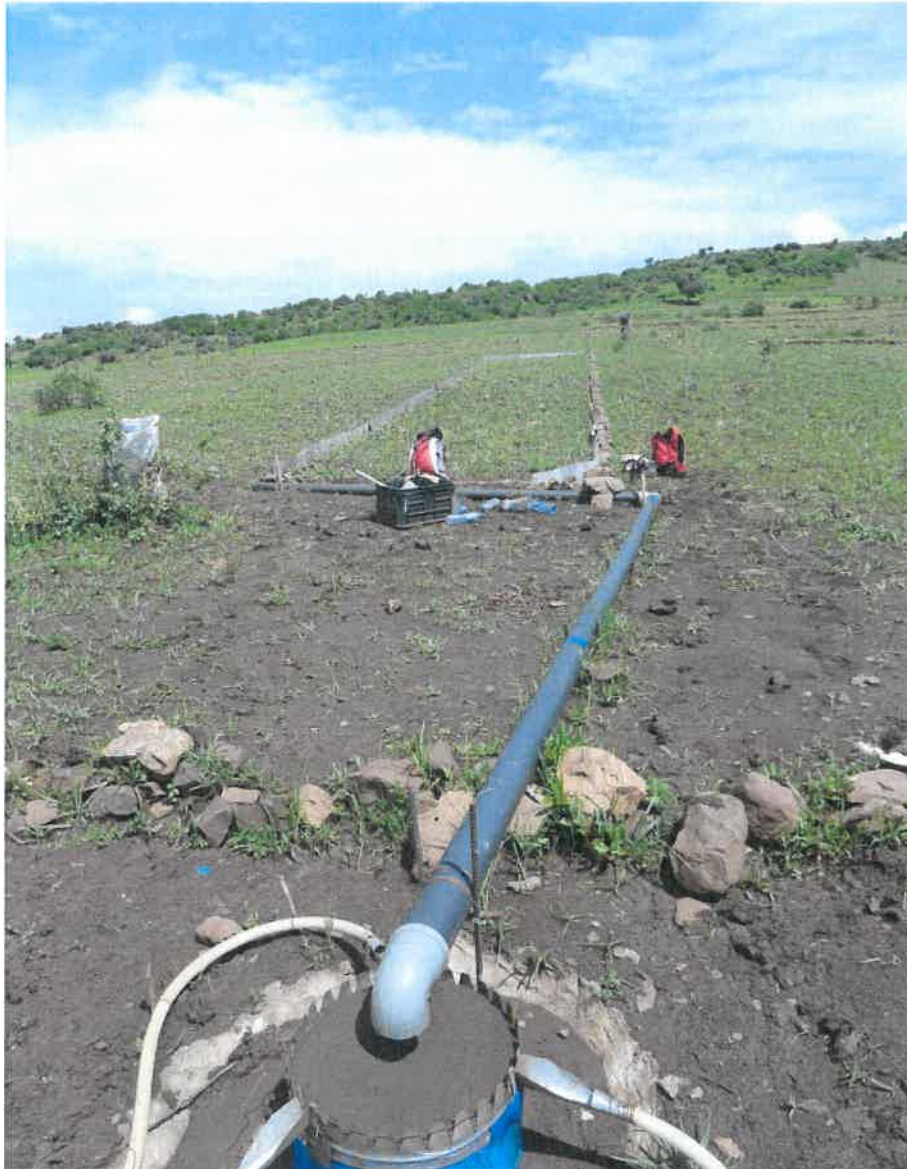
Figure 17: Untreated plot, ready for operation

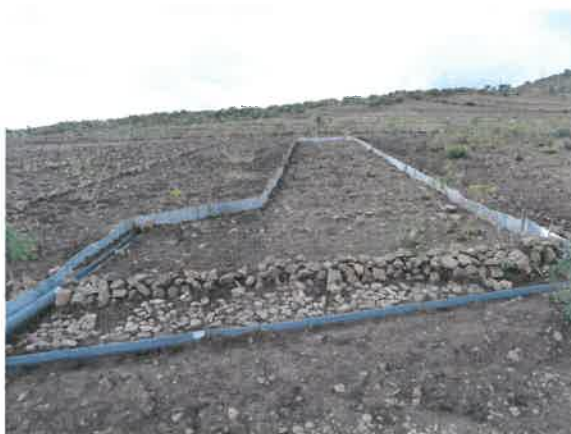
In order to get data for the treated plot, which show the effect and the importance of the maintenance of a stone bund, the stone bund was maintained in the middle of the sampling period. On the 9th of August 2013 a team of three people spent two to three hours in order to maintain the stone with a length of 4.5 m. For that purpose, stones of 10 – 20 cm of diameter were collected in the field area and mainly used for the maintenance work. At first the width of the bund and it's ground area were increased. Finally, it's height was raised from 30 cm before maintenance to 50 cm after maintenance. After finishing the work, the bund was higher and also it's permeability of surface runoff and eroded soil particles was much less than before maintenance. Figure 18 and 19 show the stone bund in two different conditions: Before and after maintenance.

Figure 19: Stone bund before maintenance

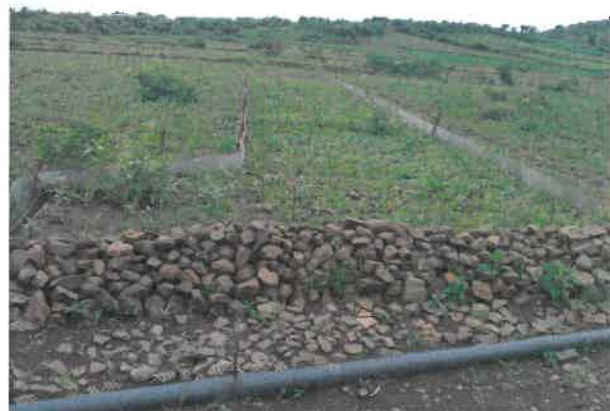
Figure 18: Stone bund after maintenance

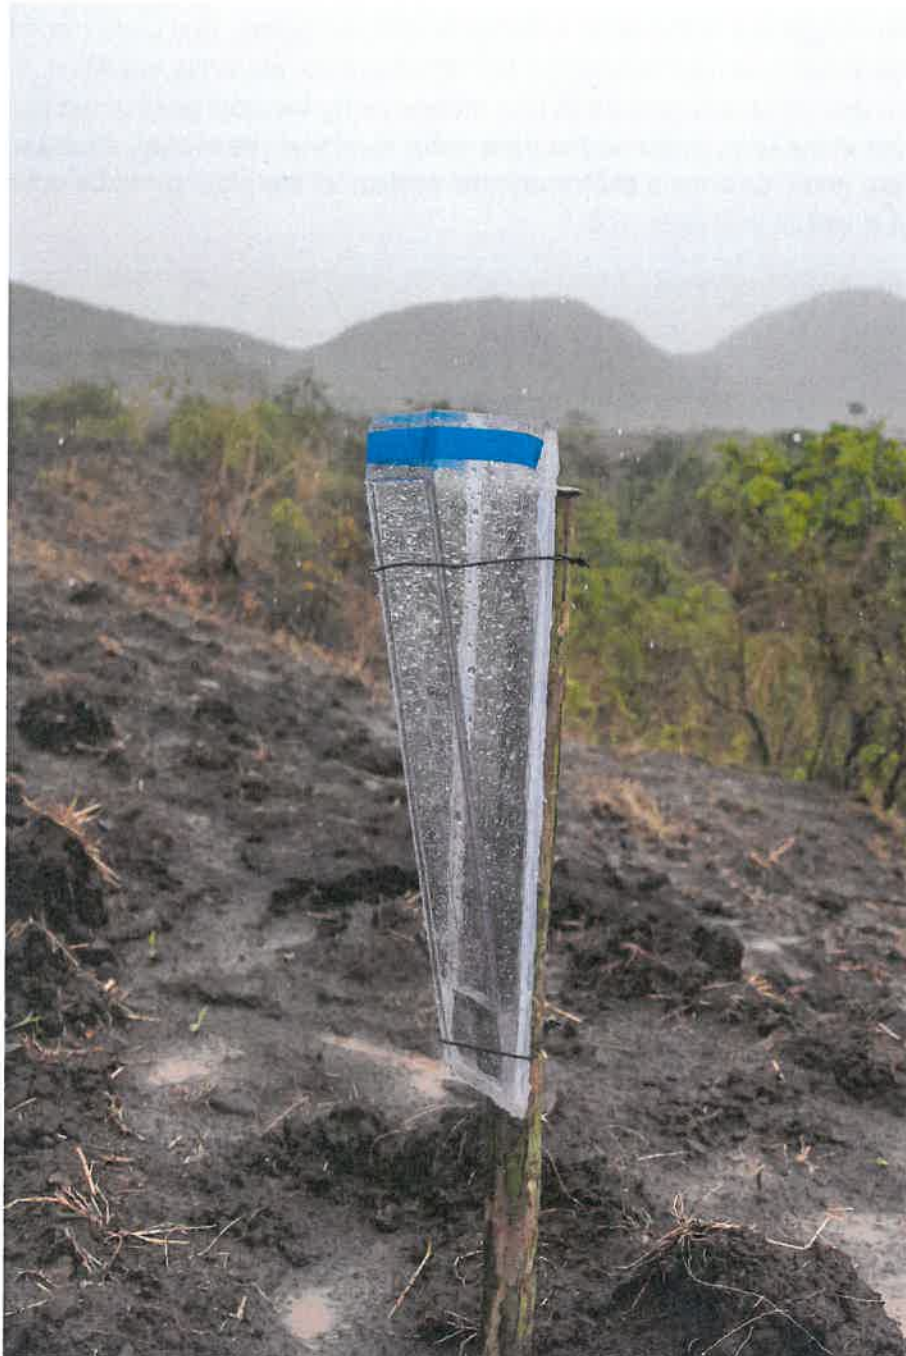
At the beginning of the construction of the erosion plots, several manual rain gauges have been installed in the whole watershed. The precipitation amount of the prior 24 hours was recorded daily at 7:00 am manually. After recording the precipitation amount, the rain gauge was emptied in order to be ready for the next measurement period. Figure 20 shows the gauging station, which delivered precipitation data for this thesis. It was located about 50 m far away from the plots.

Figure 20: Manual rain gauge (photo: Christoph Schürz)

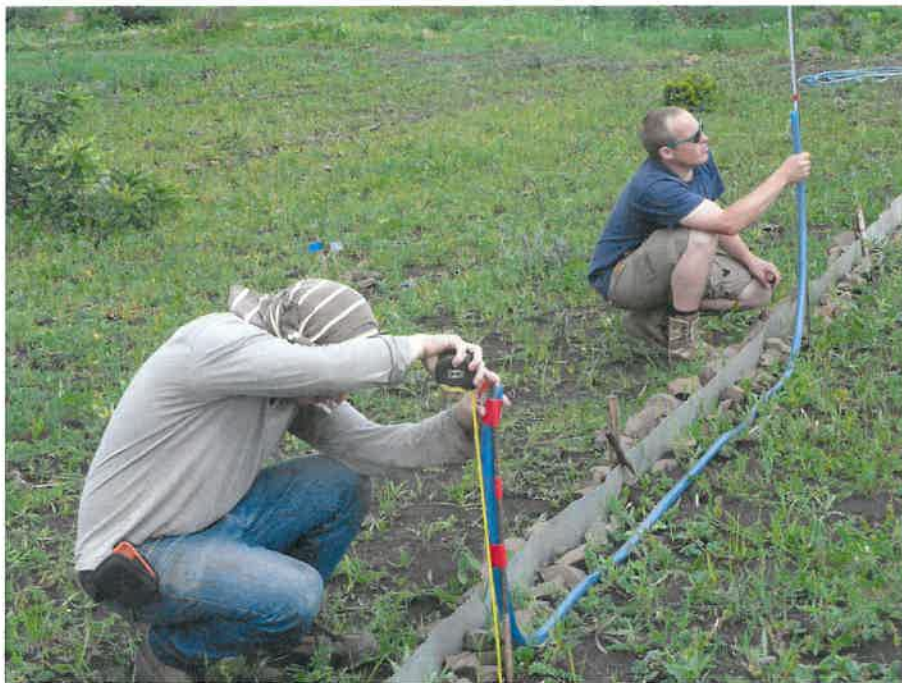
In order to get information about the slope of both plots a survey of the study area was conducted. At first the coordinates of the upper and the lower point of one length side of each plot were determined with a hand – GPS. Then, every three to four meters the relative altitude of a point of the plot length had been measured. For that purpose a tube water level was used. It was made out of a plastic tube with a diameter of 3 cm and a length of 6 m. As it is shown in Figure 21, it was bonded to an iron stick of 1 m length at both endings. The tube was filled with water for about 80% while both endings were held highly over ground, so that the water could not get out of the tube. In order to start surveying, one corner point of the treated plot was used as a reference point with an assumed reference elevation of 0 m. Beginning from that point, every three to four meters along the boundary of the plots, the difference of the water level height at the tube water level was measured. All the water level differences were noted down in a sketch and the profiles of the plots could be drawn later in AutoCAD as it is visible in chapter 5.4.

Figure 21: Surveying with a tube balance

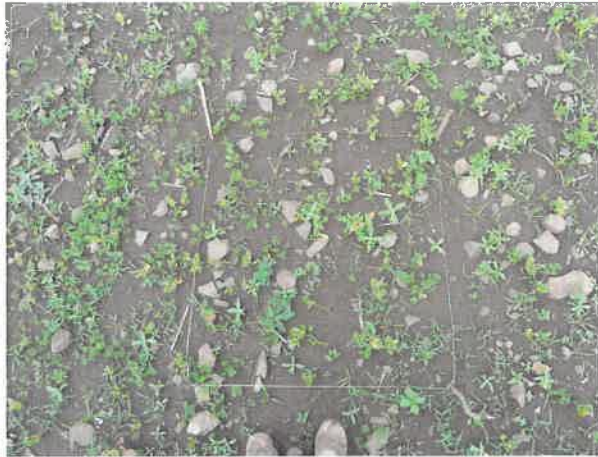
and leaf. In a next step the total area for each category can be calculated. The areas are given in pixels and their percentage is evaluated by dividing them through the total image area. The result of this evaluation is a trend of the development of canopy cover during the observation period.

Figure 24: Photo of zone 1, ready for canopy cover determination

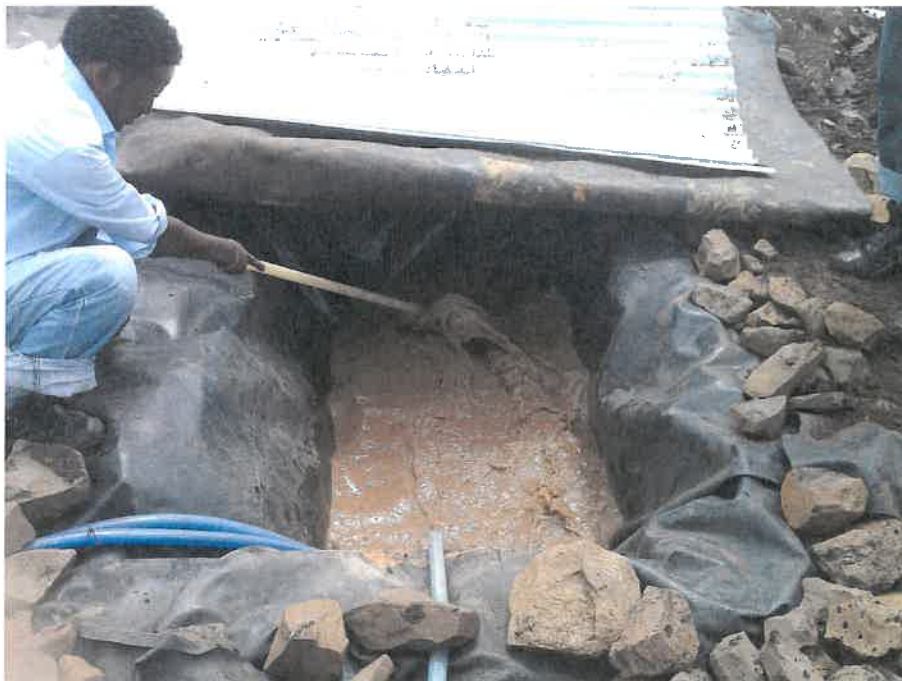
This method was the most common one and it was used on twelve out of 13 times of taking samples. After discovering the ponds, the sediment on the bottom of the ponds had to be mixed with the water by stirring it up with a wooden or a plastic stick for approximately five to ten minutes, like it is shown in figure 25.

Figure 25: Stirring up the soil – water suspension in a pond before taking samples

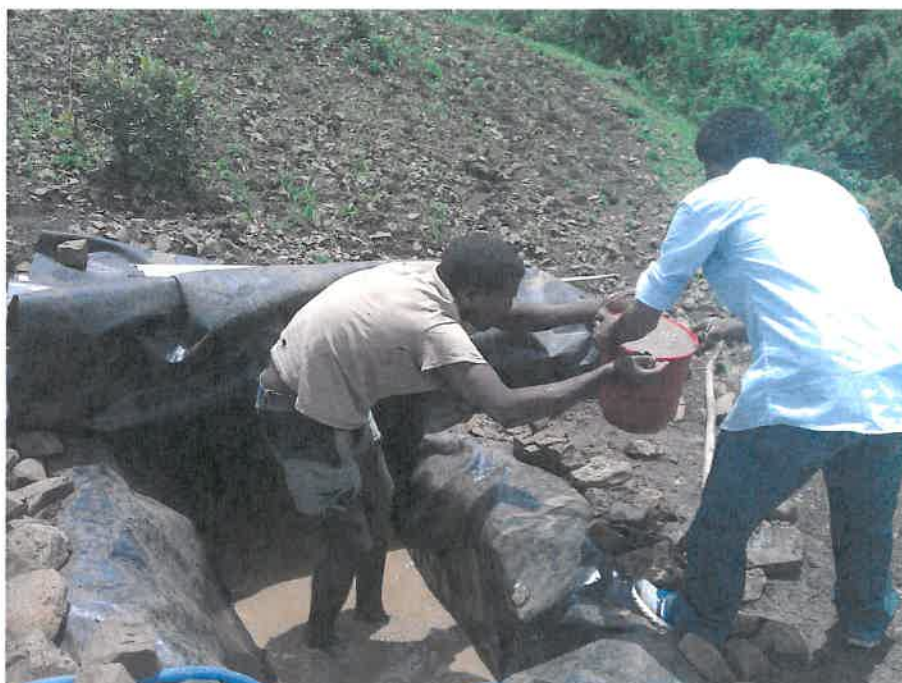
After transforming into a homogenous suspension consisting of soil particles and rainwater, samples could be taken. Depending on the amount of totally stored water in the ponds, samples with volumes between 0.5 and 1.8 l were taken with empty plastic bottles and their sample volume was determined later exactly in the laboratory. After taking one up to three samples, the remaining volume of the ponds was emptied manually with plastic buckets of ten to 20 l like it is shown in figure 26. In that way the total volume of surface runoff in the ponds could be determined.

Figure 26: Estimating the water volume in a pond by emptying it with a bucket

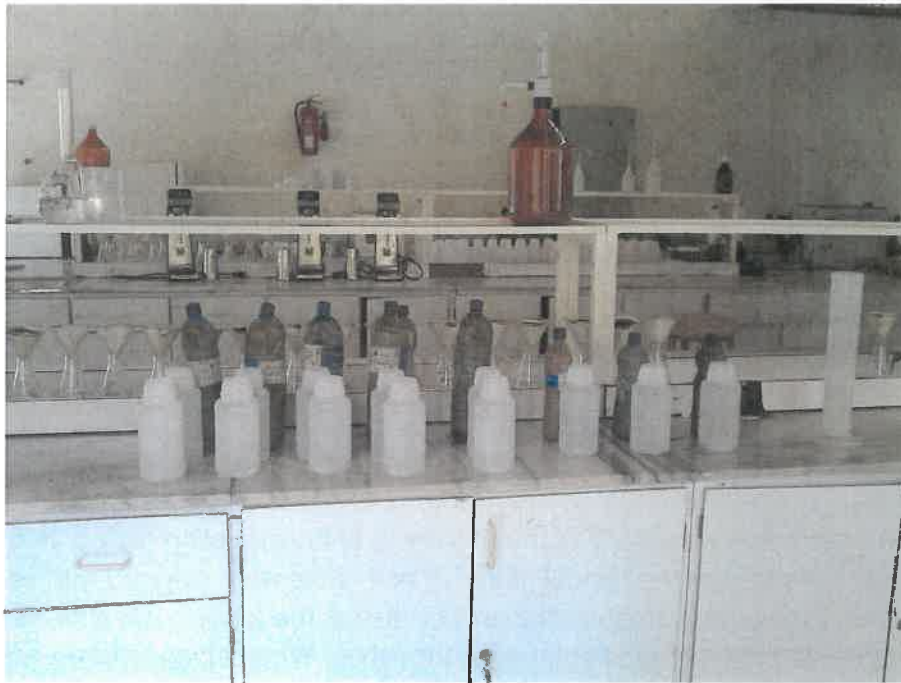
Figure 27: Soil samples in the laboratory before analysis

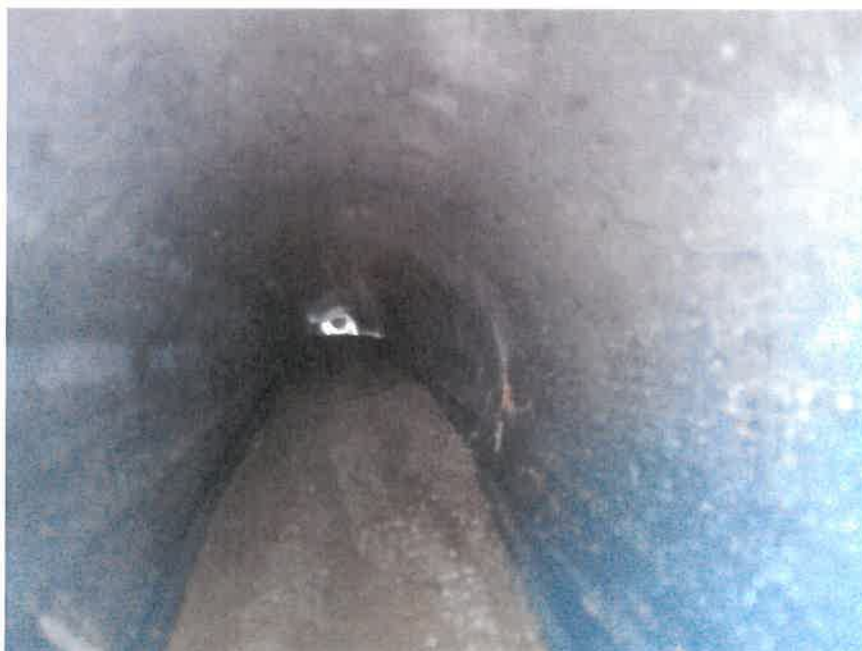
The conduit pipe of the untreated plot, which transfers the surface runoff to the sample divider was clogged totally by sediments until up to approximately 50% of its height as it is shown in figure 38. The tube was cleaned and freed from sediments totally. It is assumed that until that day, the runoff data and the soil erosion data from the untreated plot are not reliable, because the clogging of the conduit pipes was not realized for the first 20 days of measurement and therefore it could be the main reason for huge differences between data from the treated and the untreated plot.

Figure 37: Clogged tube of the untreated plot

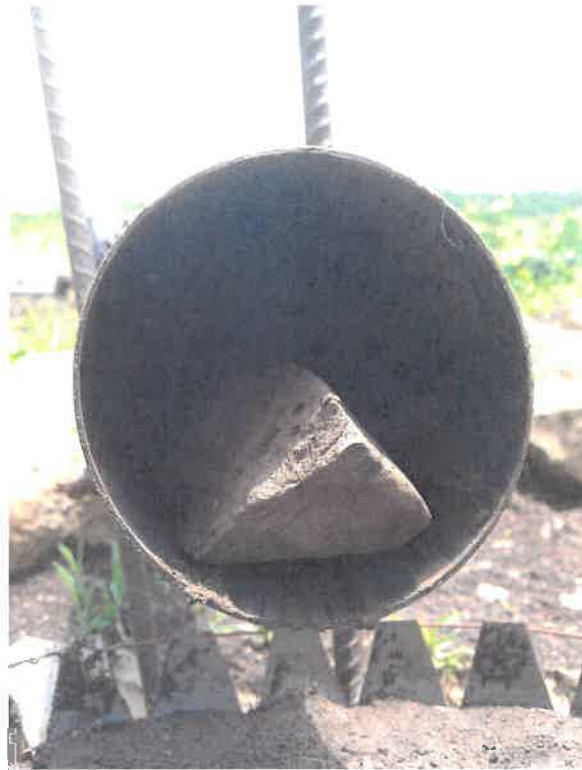
Because of the small amounts of collected surface runoff in all three ponds, the total amount of collected runoff has been sampled and its sediment concentration had been determined. In the conduit pipe of the untreated plot one big stone could be found and removed. It was obvious that the stone was put inside the tubes by humans, maybe by some local kids which wanted to play a prank. This may caused an error of the data.

Figure 38: A big stone blocking a tube of the untreated plot

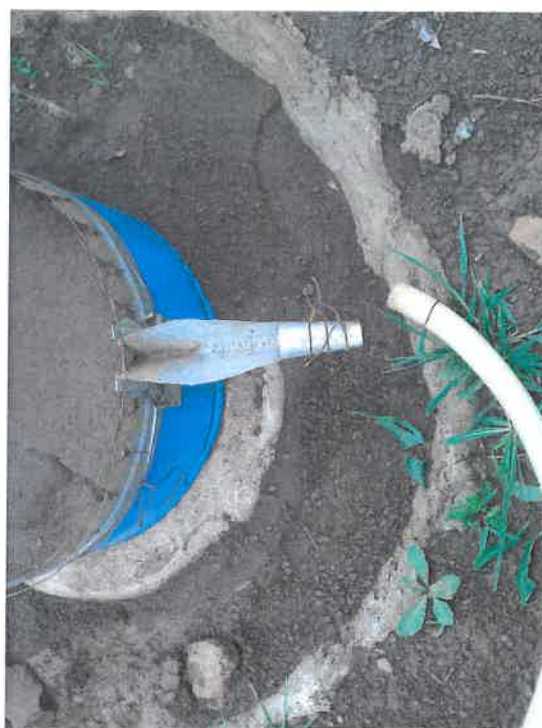
One of the three connection tubes between the sample divider and the pond of the untreated plot was removed because of an unknown reason, as it is shown in figure 40. Also the collection tube of the untreated plot was clogged by sediments, which could be removed and analyzed separately. After referring its' sediment concentration to the collected runoff amount in the UT pond, the sediment concentration was added to the before determined average sediment concentration, resulting in the S.c. average new value, as it is shown in Table A2.8b.

Figure 39: Removed connection tube between the sample divider and the pond of the UT plot
