**Evaluation of old and recently built farm roads in the selected watershed of Bhutan-an evaluation from the prospective of assessing environmental impacts.**

Thesis submitted in partial fulfillment of the requirement for the degree  
of  
**Master of Science in Mountain Forestry**

UNI BOKU Vienna

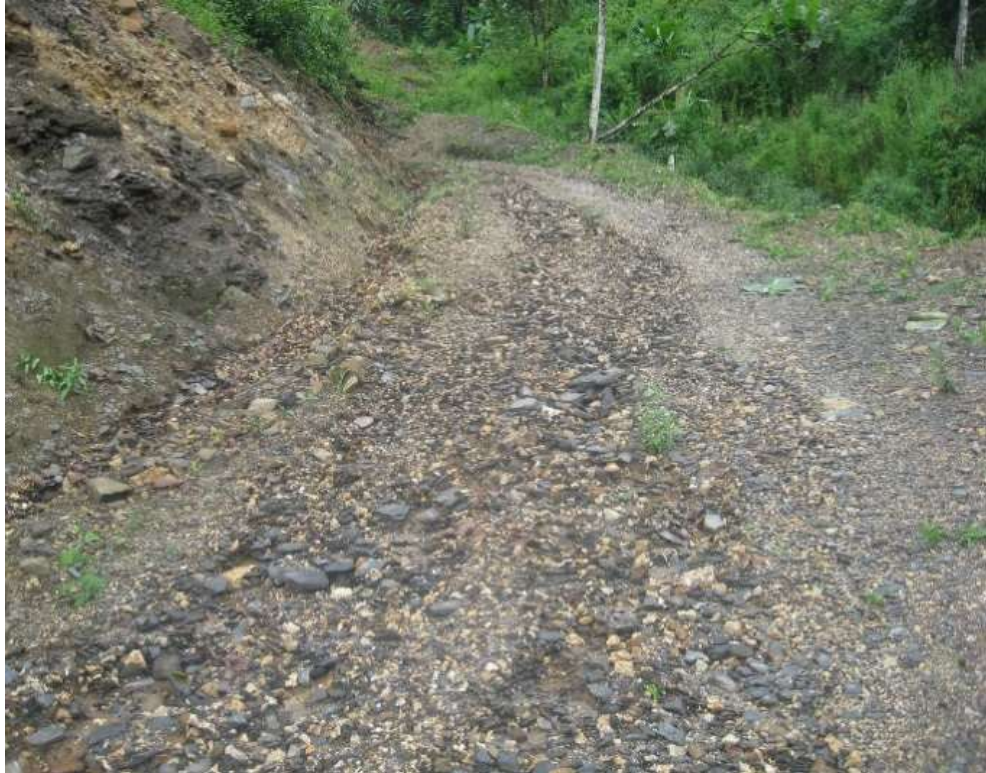
12), which are subjected to higher intensity of road surface erosions during monsoon seasons (Photo 2). Due to steep road gradients, road surfaces were severely eroded leading to the formation of deep erosion channels at several spots along the roads (Photo 7 and 8). Road sections with gradients less than 2 degree (3%) were mostly water stagnated due to lack of water drainage facilities. The stagnant water seeped into the road subgrade soils making the road surface clayey, leading to developments of ruts after vehicle movements (Photo 3). Also these sections of the road were deposited with debris and sediments carried by the runoff water. Road blocks caused either by accumulated debris/sediments or unstable road surface due to water stagnation were common along the roads.

*Photo 2: Road surface highly eroded due to steep road gradient (more than 7 degree or 12%)*

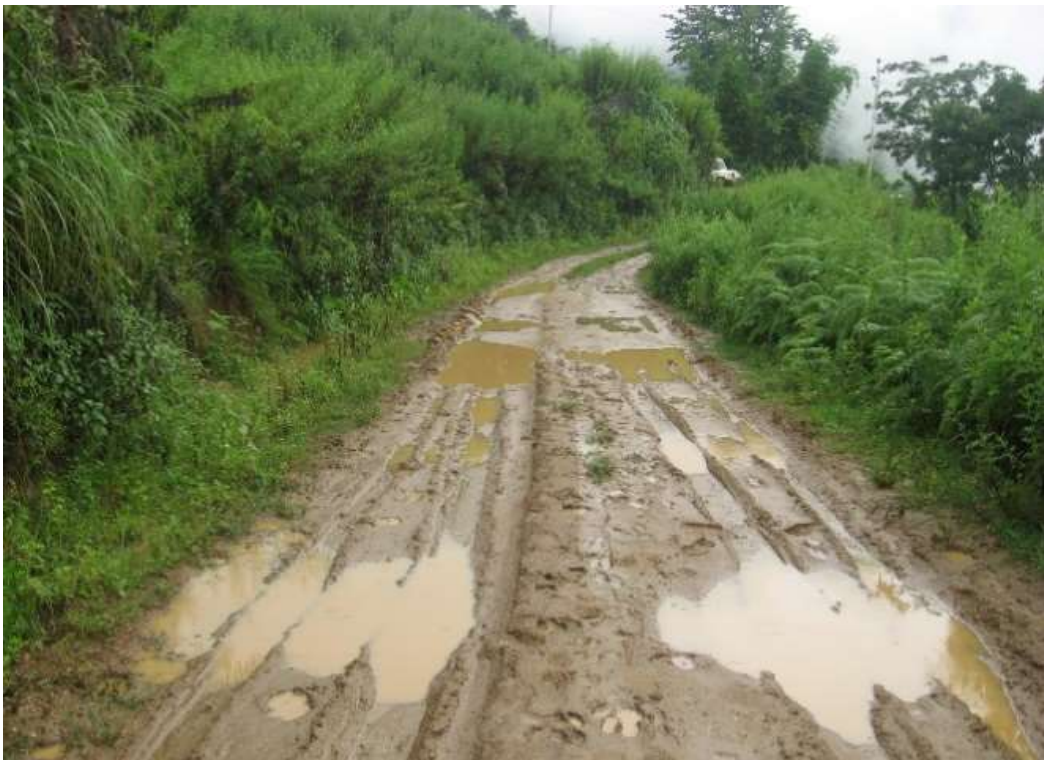
*Photo 3: Water stagnation due to poor drainage and very low road gradient (less than 2 degree or 3%). Development of ruts on the road surface due to vehicle movements*

source of sediments (Photo 9). On flat grades, the major problems were water stagnation, deteriorating the subgrade and leading to development of ruts which severely deterred the road surface quality (Photo 3). The ruts thus formed are also a major source of sediments for downstream sedimentation (Brink, Slate et al.) Subsequently, these sections of road are bottle necks which are detrimental to road functionality and environmental impacts.

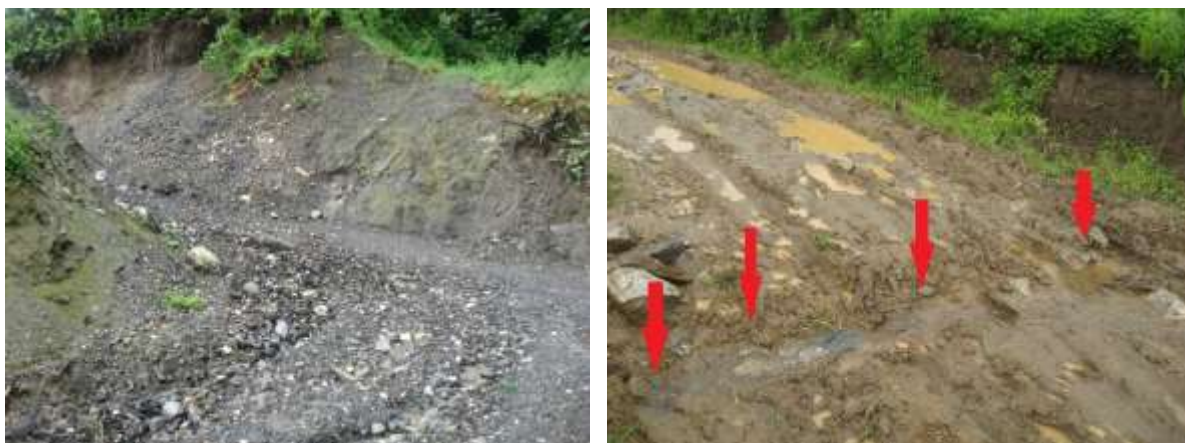
*Photo 4: (Left) Road surface severely eroded due to runoff water on Gajeb farm road.(Right) Irrigation channels coming in conflict with the road alignment damaging the road surface*

Gajeb farm road is in the worst condition with about 60% of total farm road in bad and very bad conditions (Photo 4 Left), followed by the Deorali and Upper Tashithang roads, both of which have approximately 40 % of the total road length in relatively bad to very bad conditions. Balaygang I and II, as well as the Goshi farm roads are intermediate with about 20-25% of the road length in bad to very bad conditions. Tashitang farm road is relatively good with only about 13% of the road length in bad condition (Table 8 and Figure 14). The road condition is also deteriorated on several spots due to irrigation cannels coming in conflict with the road alignments (Photo 4 Right). The spatial distribution of the road quality is shown in the map below (Figure 15).

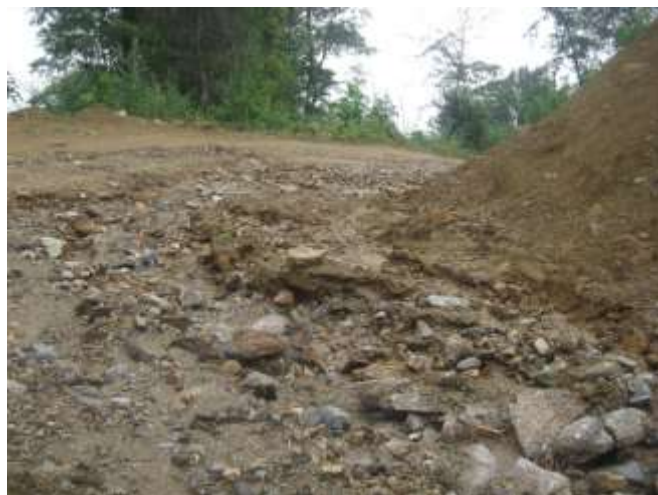
Photo 5: Erosion cannel formed due to surface runoff in the absence of side drains

The water canals are absent mostly in newly constructed farm roads which are even more prone to soil erosions due to bare subgrade soils exposed to precipitations. Absence of water canals in combination with loose bare subgrade soils, has led to excessive erosions due to runoff water leading to the formation of deep erosion cannel at several spots. The road is rendered completely un-useable during the rainy seasons (Photo 5). The road is not useable even during the dry periods of the year unless with major maintenance works. In many instances, the erosion cannel have also destroyed the irrigation cannel of the villages, mostly due to siltation and deposition of debris in the irrigation cannel, diverting the course of the irrigation cannel completely.

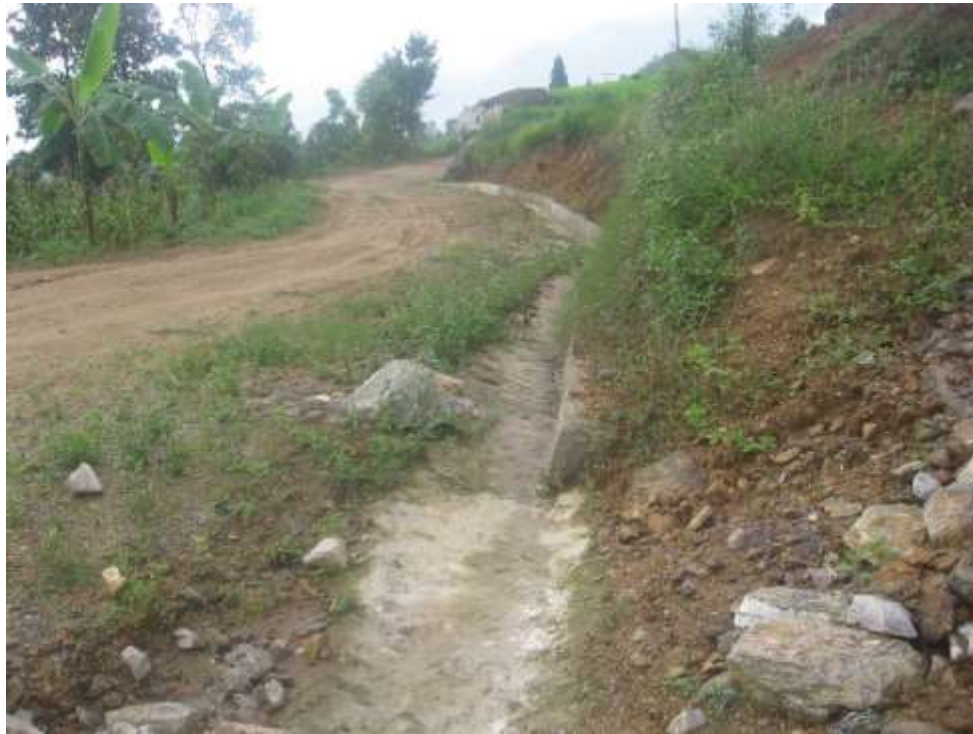
*Photo 6: Side Drains for Goshi farm road in the watershed*

Even with the existing water cannels, most of the channels are defunct/blocked with debris of past monsoon. Such blocks were mostly noticed on road sections with minimal gradient causing water stagnation. The stagnant water either flowed over the road pavement deteriorating the road surface, or seeped into the road surface destroying the road subgrade soils. The spatial distribution of water cannal depths is illustrated in Figure 20.

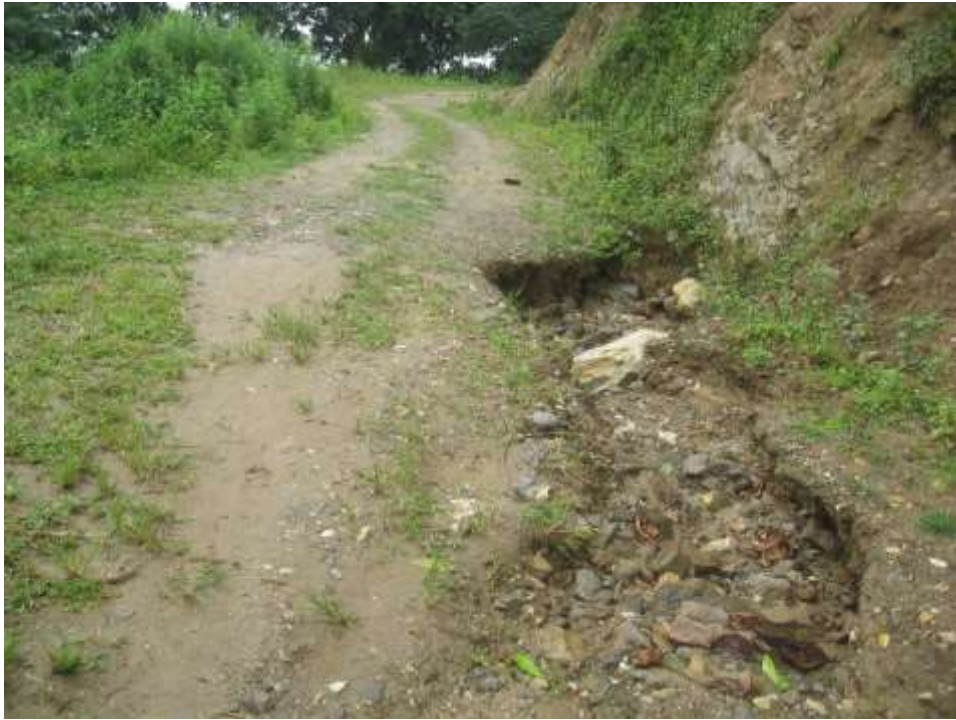
*Photo 7: Deep erosion cannels formed on the road surface*

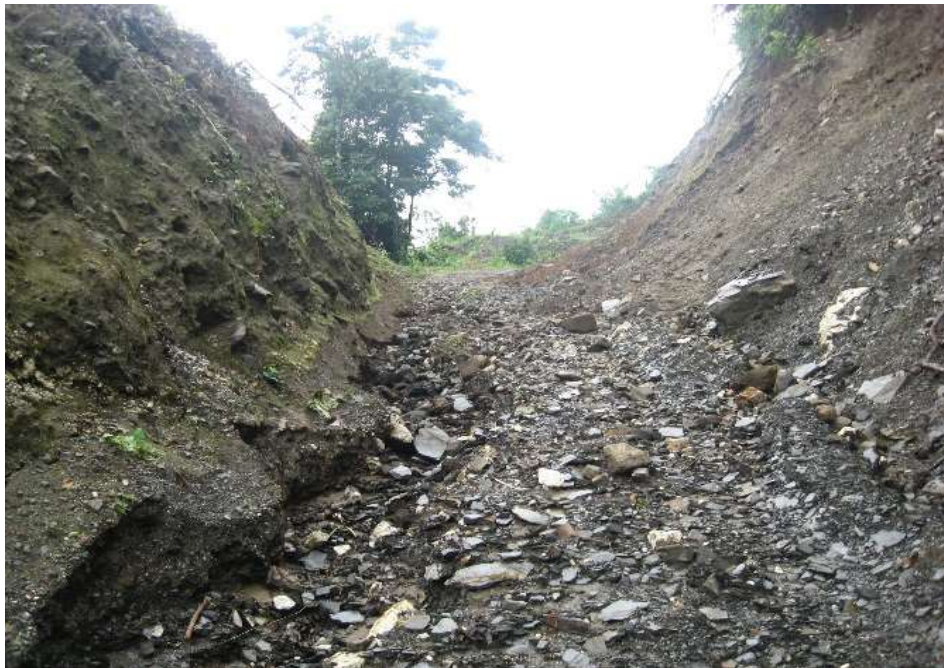
*Photo 8: Road surface severely eroded due to excessive runoff*

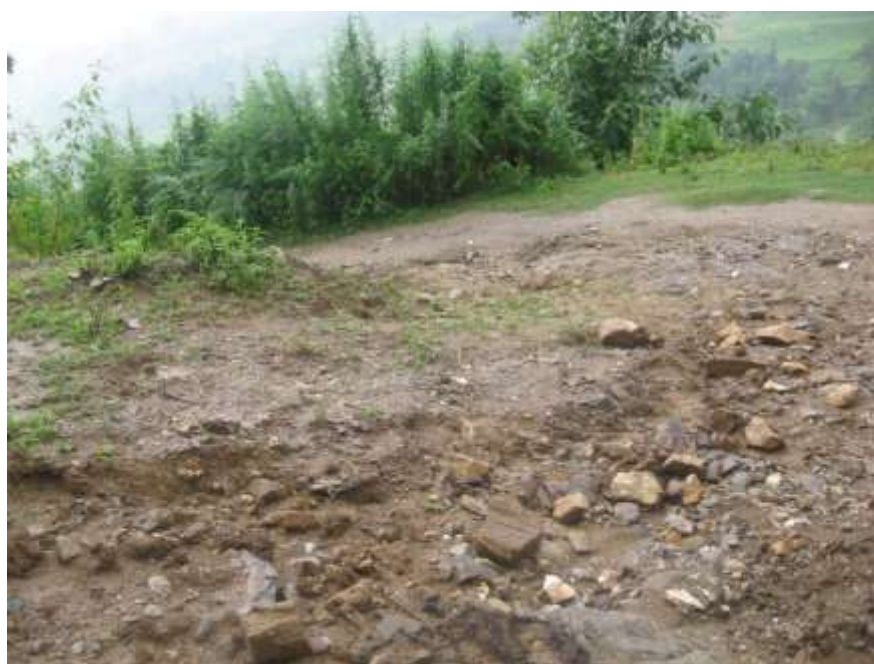
*Photo 9: Erosion canal on the Pungshi Farm Roads*

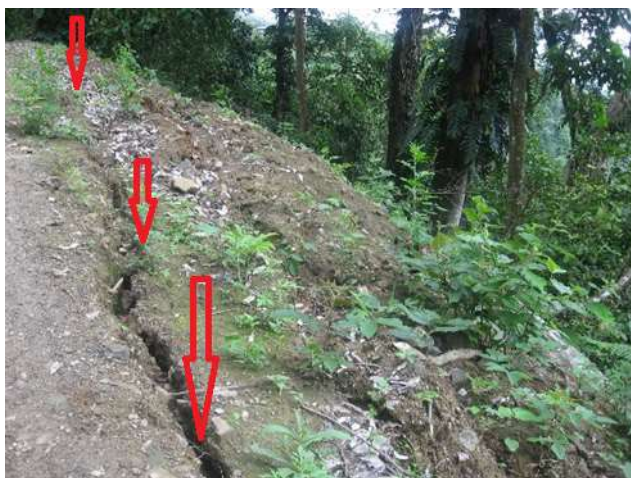
*Photo 10: Arc shaped cracks indicating slope failures*

alignments ,ignorance of terrains conditions during road construction ( swampy, moist, steep) and absence of stabilization measures. The arc shaped cracks on the road edge were observed frequently both in old as well as new farm roads of 3 to 10 meters length. The cracks on the road edge are good indications of soil erosions and fill slope failure in near future (Photo 10).

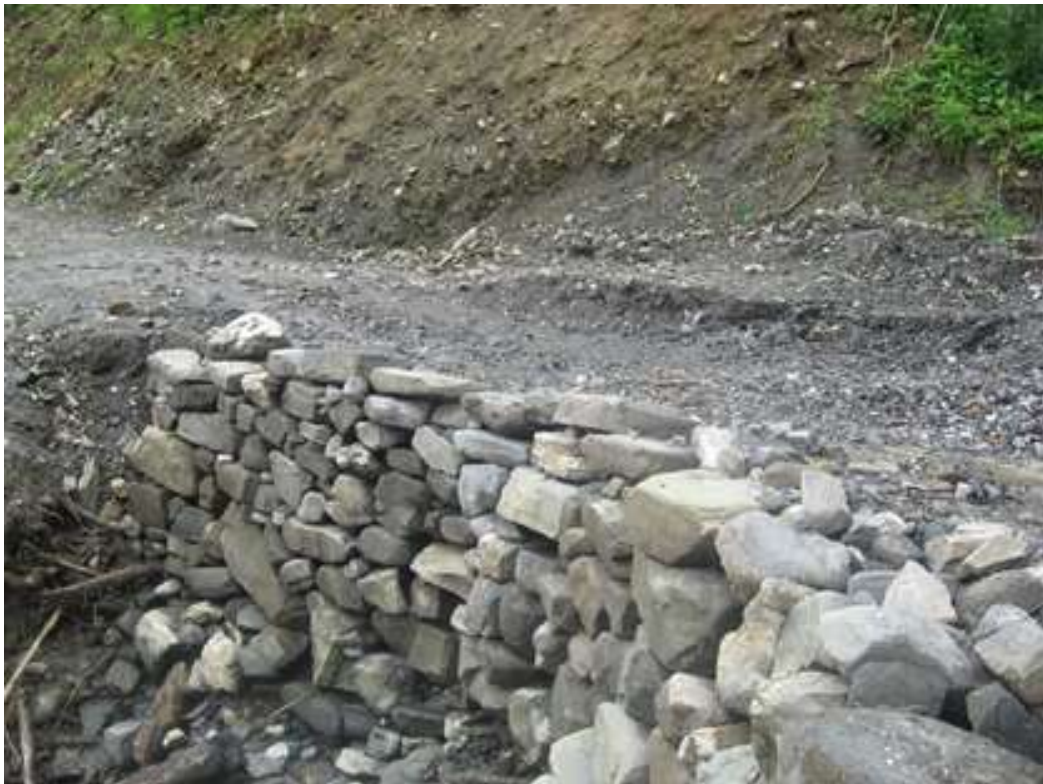
retaining walls (Photo 11), no other stabilization measures (vegetative or bio-technical stabilization) were taken along the entire sections of farm roads. In older farm roads, the stability of the fill slopes is entirely a work of nature where fill slopes have been adequately vegetated naturally (Photo 14).

*Photo 11: Locally made retaining walls*

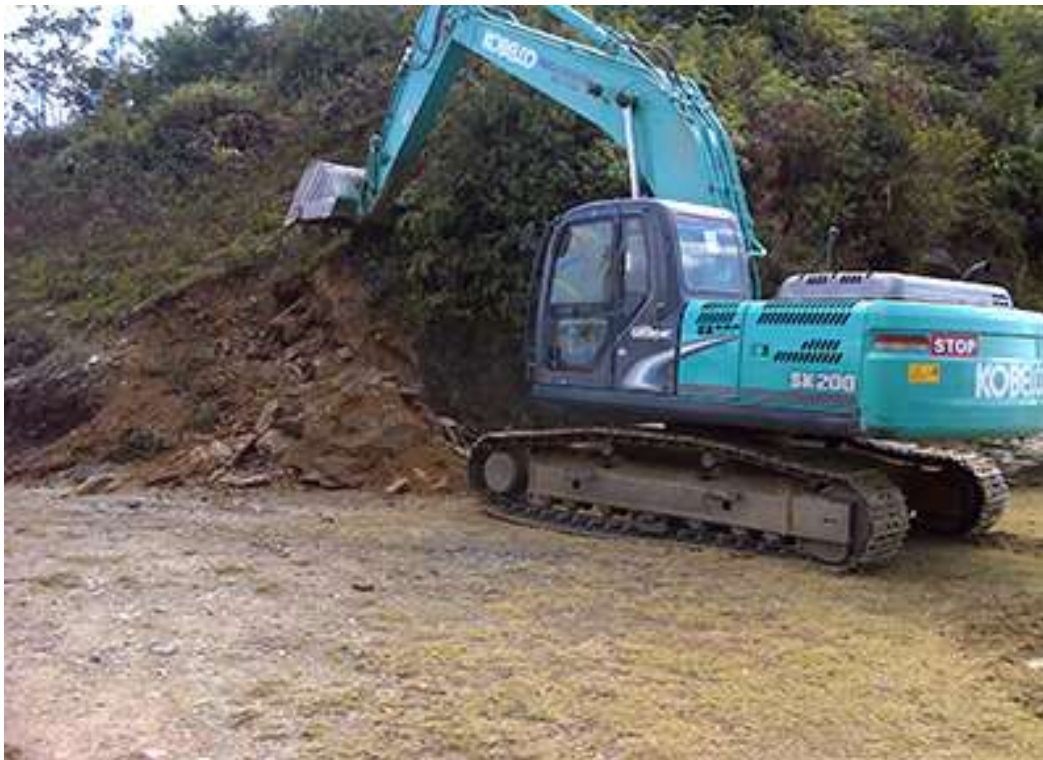
The mean value for the fill slope is 28.18 ( $\pm 0.475$ ) degree, with a maximum of 53 and minimum of 0 degree. Almost 77% (32 800m) of the total 42 600m of farm roads has fill slopes below 30 degree. Majority of the road lengths have fills slopes within the range of 21 to 30 degrees (Table 12). The steeper fill slopes are noticed especially on terrains which are steep (Figure 27). Also generally the higher fill slope has corresponding higher fill slope length which in turn increased with the increasing terrain slope. The downhill environmental impacts were observed to be more severe with the increasing fill slope and fill slope length. Since most of these fill slopes comprised of excavated materials that had been randomly deposited on the steep slopes by excavators without any retaining structures or biotechnical stabilization measures, occurrence of downward landslides and multiple cracks on the road edge were observed frequently along these road section (Photo 10 ). The technical knowledge of the excavator operators and the presence of engineers at the site during the excavation works will have a crucial impact on the competency of the work done in such steep terrains (Photo 12)

*Photo 12: Excavator at work*

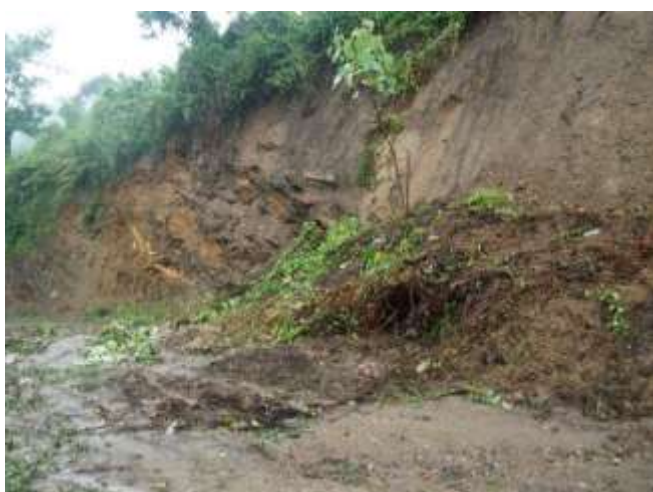
*Photo 13: Erosion and road blocks due to cut slope failure*

Cut slopes for old farm roads are fairly well vegetated compared to newly built farm roads. Thus, generally it was observed that cut slope for old farm roads are more stable than those of new farm roads. However, instances of cut slope failure was observed both in old as well as new farm roads (Photo 13). The most probable factors leading to cut slope failure are generally due to acute cut slope angles, deep and loose unstable soils on

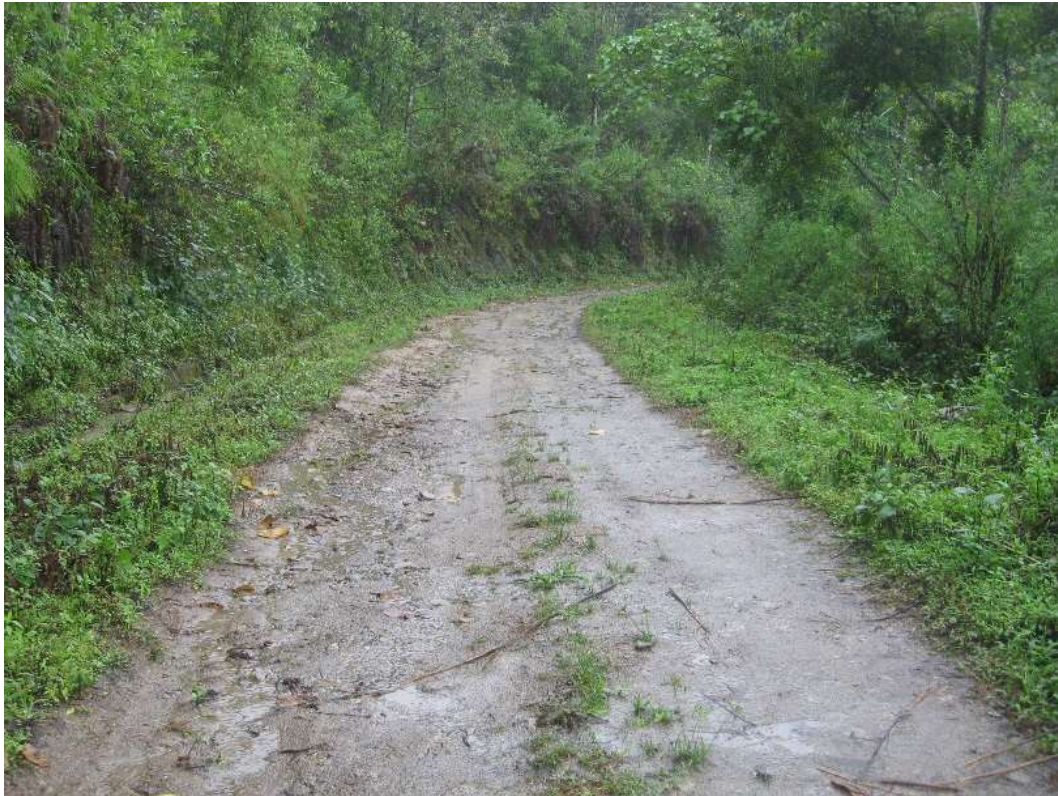
processes, either by re-vegetation or the slope getting seasoned overtime on its own (Photo 14).

*Photo 14: Naturally vegetated cut and fill slope*
