SUSTAINABLE WATER MANAGEMENT AT VALLEY VIEW UNIVERSITY, GHANA – Evaluation and Further Development

**Master's thesis
Natural Resources Management and Ecological Engineering**

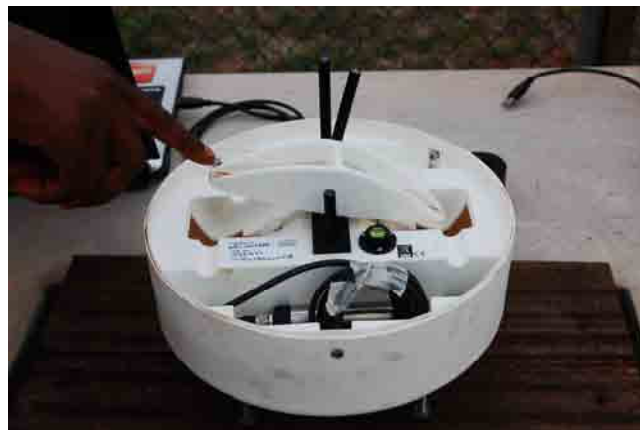
Figure 4.1: Tipping-bucket and rainlogger

The Rainlogger was set to a sampling rate of 5 minutes and to a fifteen-minute maximum rainfall sampling. In the dry season, the sampling rate should be adapted to about 15 minutes. Monthly data download was advised as well as regular checks of the tipping-bucket.

The Rainlogger “will provide the total rainfall within the sample interval. It does so by multiplying the number of tips within the interval by the tipping bucket’s calibration factor. The calibration factor is the amount of rainfall depth [mm] per tip” (SOLINST, 2009).

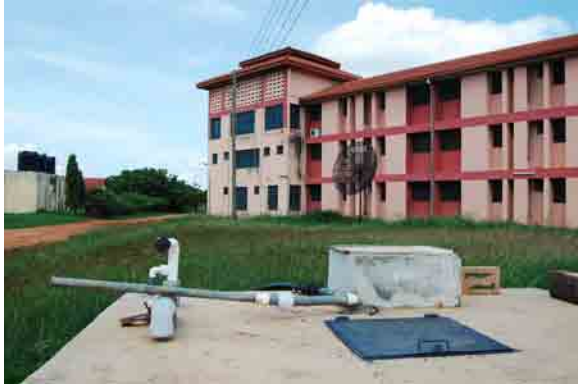
Figure 5.19: Broken grey water pump

Broken pumps and leaking rainwater tanks are a big problem at VVU (see Figure 5.19 and Figure 5.20). Thus, several rainwater harvesting systems do not work properly. A lack of finances makes it hard to replace these facilities.

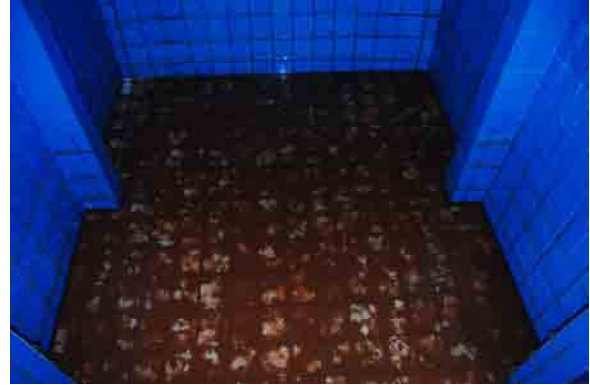
Figure 5.20: Broken rainwater tank

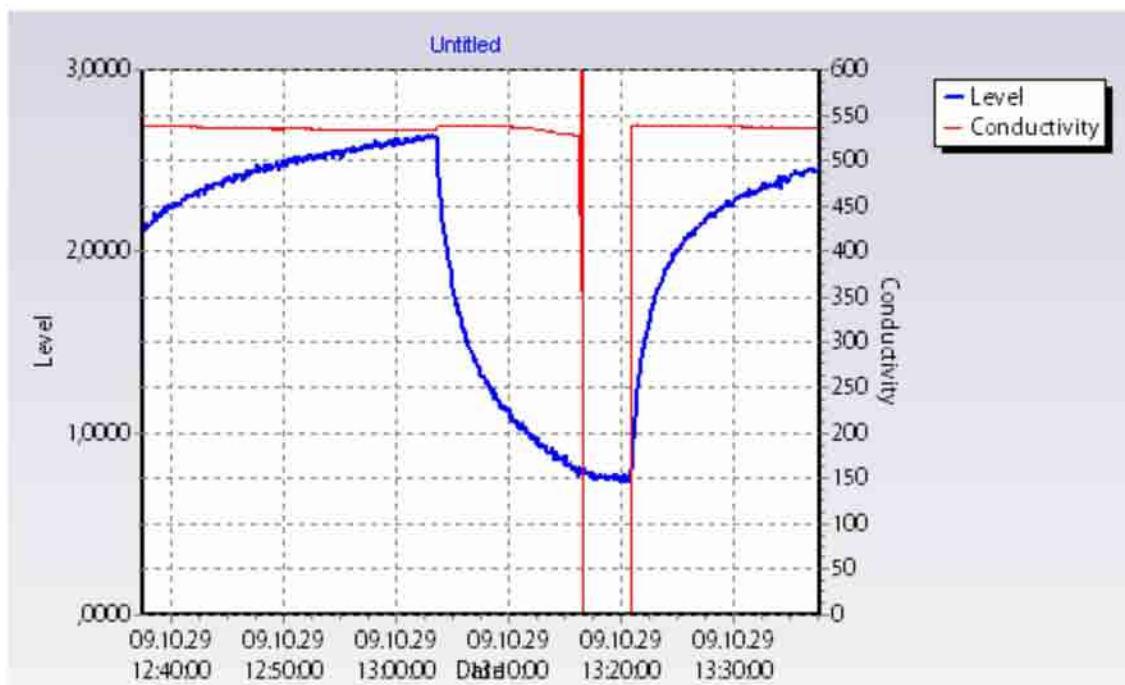
Figure 5.23: Comparison of level and conductivity measurements at Borehole 2 during a test where the measurement rate was set to 5 seconds
